Service Note

Oil filler cap

For Mecanil grapple saws, especially SG160RC-series when transporting the grapple in an upright position. There have been reports that chain lubrication oil may leak through the breather hole in the oil cap.

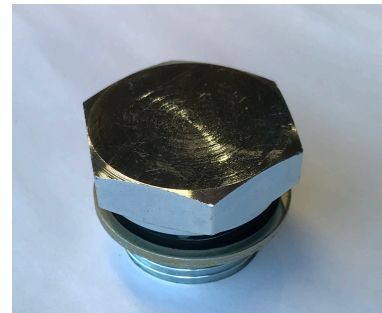
To solve this problem we have tested to use a completely sealed cap instead of the original cap.

The test was completely successful with no problems, the tank was completely drained by normal saw action. Although there was a vacuum buildup in the tank, everything worked normally. However this was made under "laboratory" conditions in 23 C° (73,5 F°).

If users have problems with oil leaking through the vented cap, this may be tested. We do not foresee anything in the field making this problematic but follow up is recommended.
